(Output Paper)

Beach Sampling and Characterization in Ajegunle, Lagos, Nigeria

April 2025

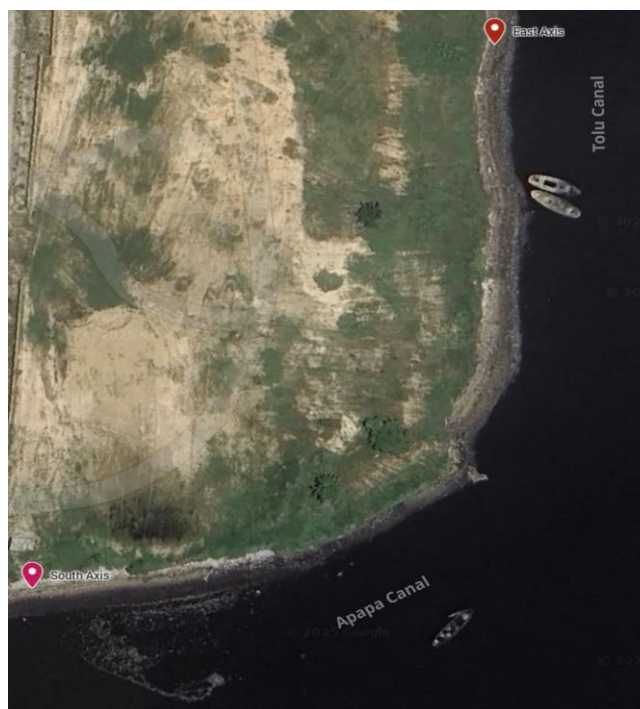
Figure 1: Satellite Images of Apapa Canal and Tolu Canal in Ajegunle, Lagos

This beach sampling study, conducted as part of PROTEGO's Work Package 1, was carried out on March 20th and 21st, 2025, during low tide and under sunny weather conditions. Two key locations were selected for the sampling exercise: the south side of the Apapa Canal (6.43645 N, 3.34749 E) and the east side of the Tolu Canal (6.43809 N, 3.34872 E). The activity took place from 12:47 p.m. to 1:35 p.m. at Apapa, and from 1:09 p.m. to 1:47 p.m. at Tolu. A satellite image of the Apapa and Tolu Canals, showing the designated sampling sites, is presented in Figure 1 below.

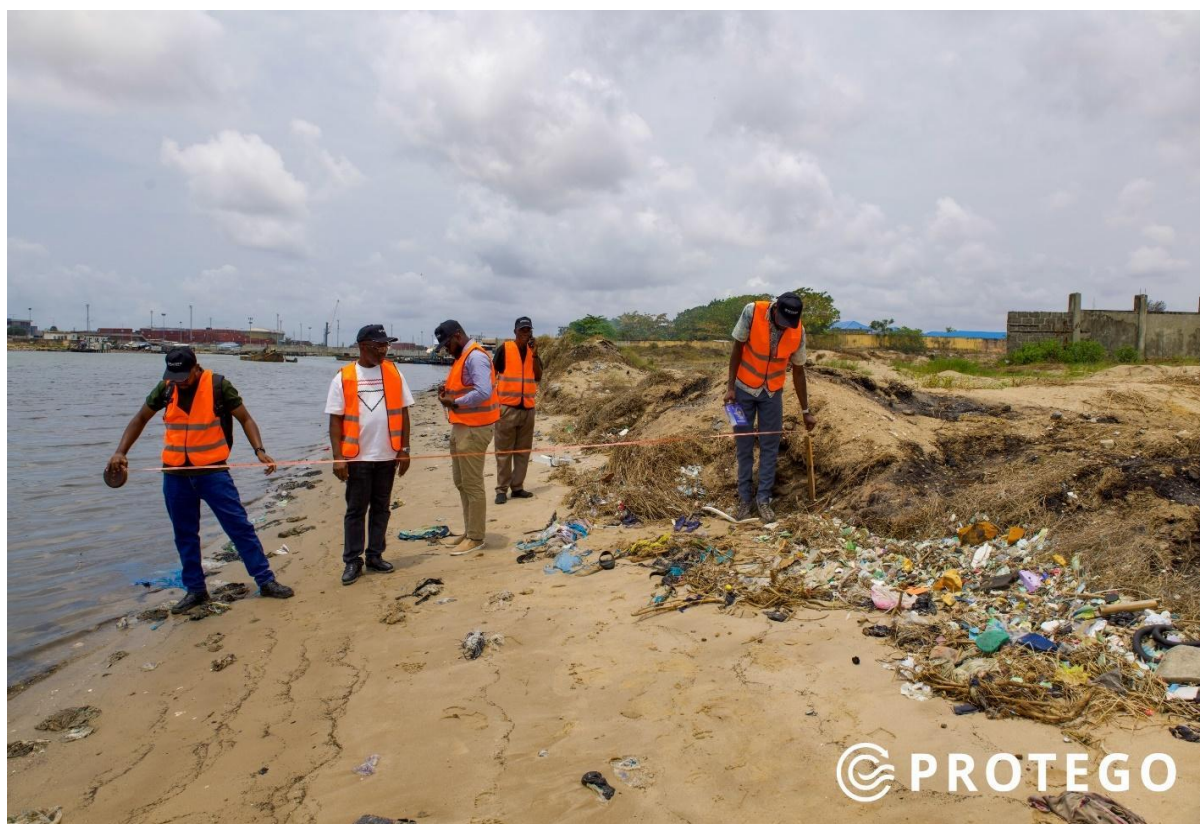
Figure 2: Sampling Transect demarcation at Apapa Canal (South Side Axis), Ajegunle

Figures 2, 3 and 4 above show the sampling transect demarcation at the Apapa Canal (South Side Axis) and the waste transect before and after sampling and cleaning at the Tolu Canal (East Side Axis), respectively. The various waste types found within the transects established on both canal banks were sampled over a period of 48 minutes on the South-side axis and 38 minutes on the East-side axis to ensure a comprehensive representation of the available waste materials. The collected waste from both transects was separately bagged and tagged for further analysis.

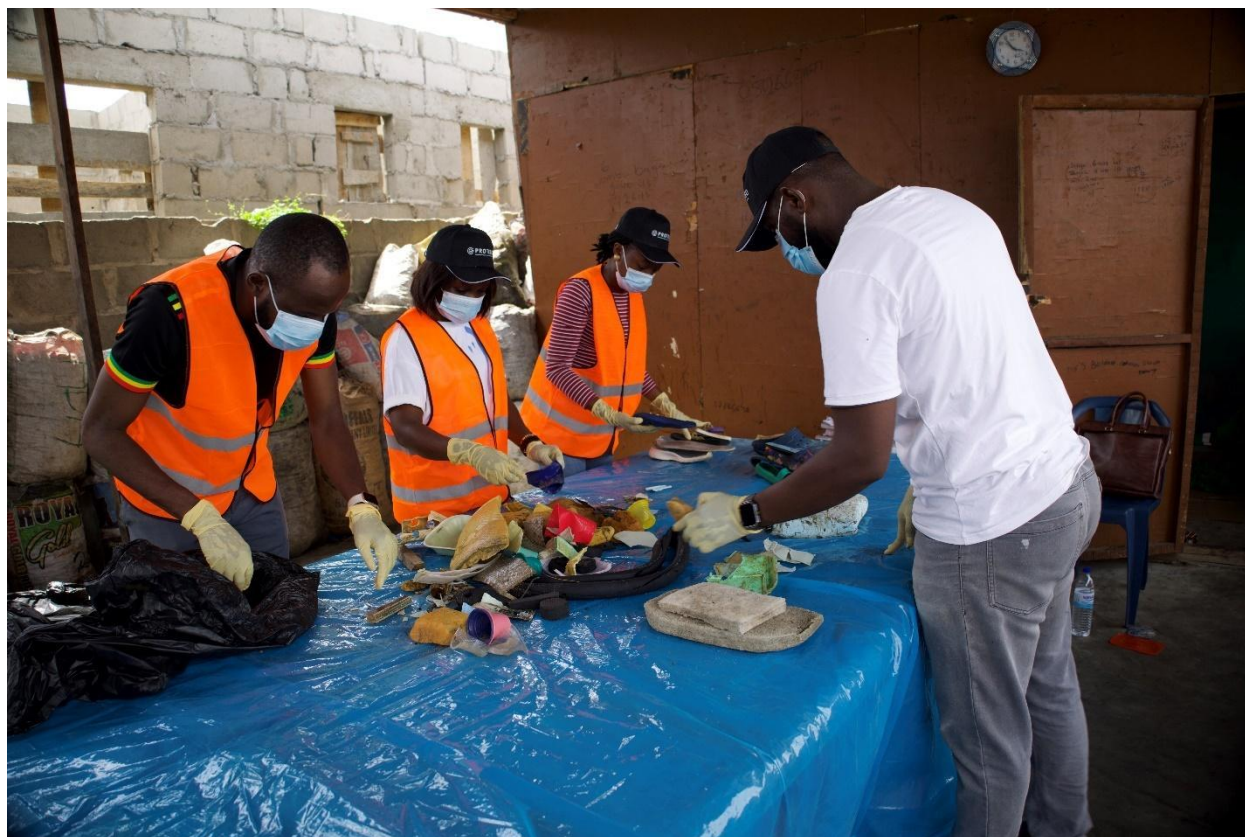
Figure 5: Waste Sorting and Characterization Activity

The waste collected from each transect was placed on a table and categorised by type. Subsequently, the number of items in each group was counted and then weighed. Figure 4 shows the waste sorting and characterization activity by the PROTEGO team.

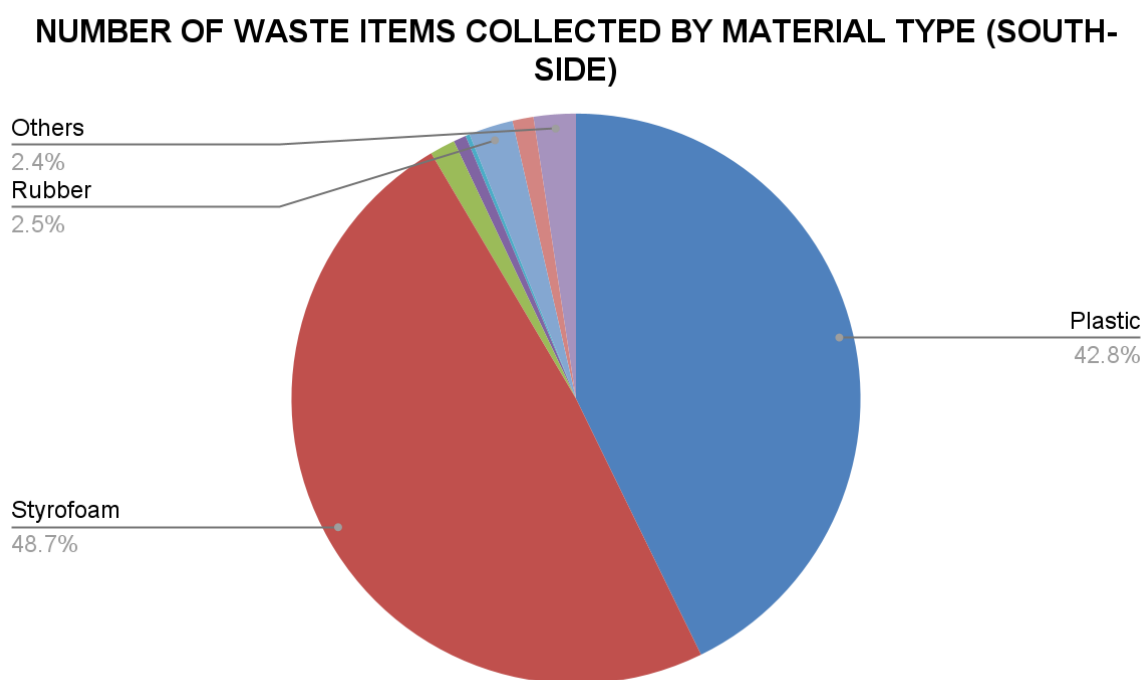
Figure 12: Waste quantification in South Side Beach

The chart in Figure 11 illustrates the quantity of waste collected along the South Side Axis, categorised by material type. Styrofoam and plastics together make up the vast

majority of the waste, accounting for a cumulative 91.5% of the total items, while smaller contributions come from rubber (2.5%), textiles (1.4%), and other materials (2.4%).

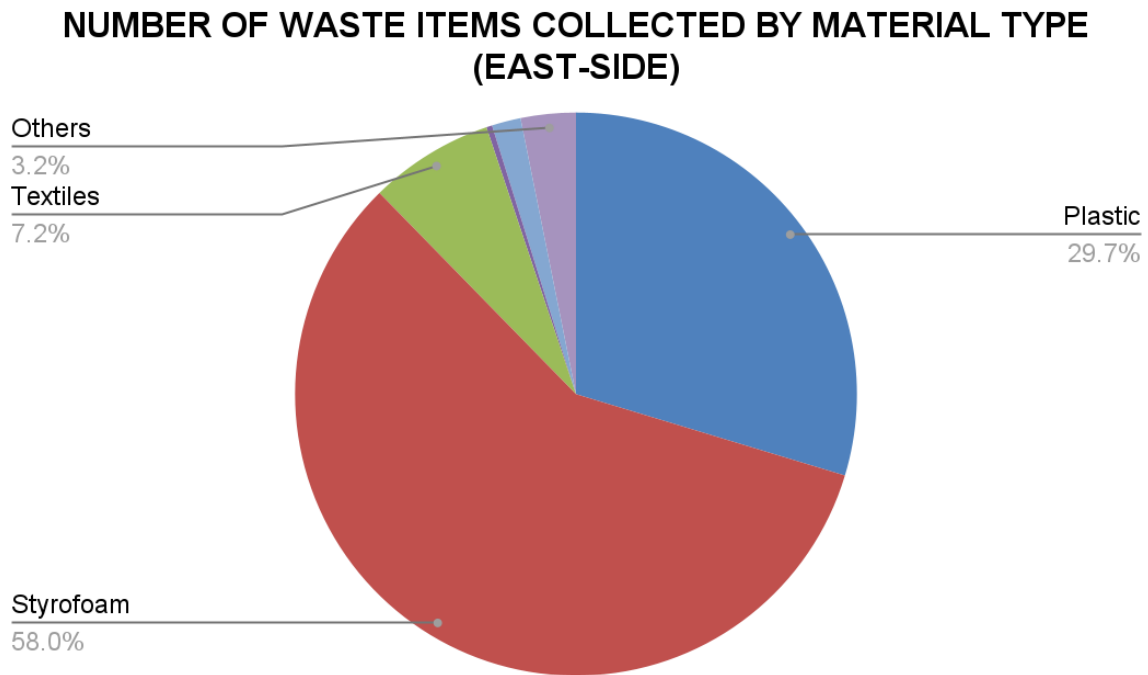
Figure 13: Waste quantification in East Side Beach

The chart below illustrates the quantity of waste collected along the East Side Axis, categorised by material type. Styrofoam and plastics together dominate the waste composition, accounting for a cumulative 87.7% of the total items, while textiles (7.2%) and other materials (3.2%) make up smaller portions.
